# ParaDrain™ - Case History

## Slope Stabilization After Failure Wan Li, Taipei - Taiwan ROC

ParaDrain™ grade use: ParaDrain™ 100/15  
Client: Taipei County Government  
Design: Johnson Engineering Co. Ltd.  
Contractor: Fu-Yi Construction Co. Ltd.

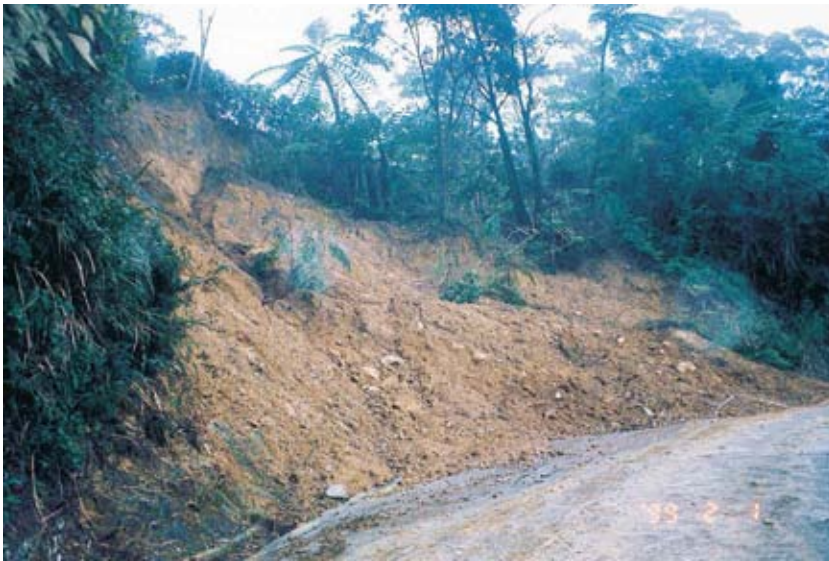
Such a major event occurred in 1999 resulting in many slope and other failures which caused significant disruption and loss of life. One such failure occurred on a hill road at Wan Li near Taipei, capital of Taiwan.

During the typhoon season a build up of pore water pressure in a section of slope on the uphill side of the single carriageway road coupled with generally poor drainage caused a collapse of the slope and consequent closure of the road. The technique of soil reinforcement using ParaGrid™ is a very common and popular means of effecting slope repairs in Taiwan.

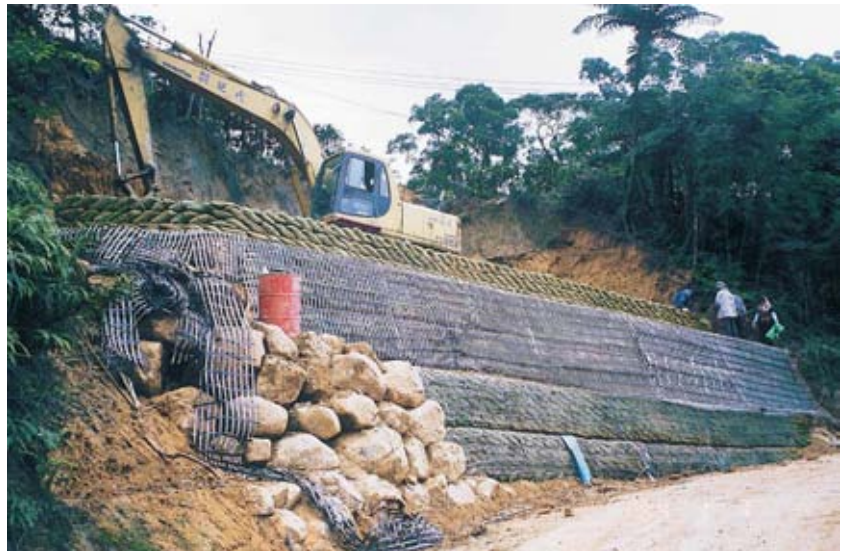
The reconstruction of slopes can be carried out quickly and cheaply using simple methods which result in stable but flexible structures. Rapid vegetation growth coupled with adequate drainage ensures that a stable repair is achieved which is capable of withstanding the effects of typhoons and earthquakes. However the seasonal storms and poor soil conditions limit the suitable construction period available using these techniques to the summer months only.

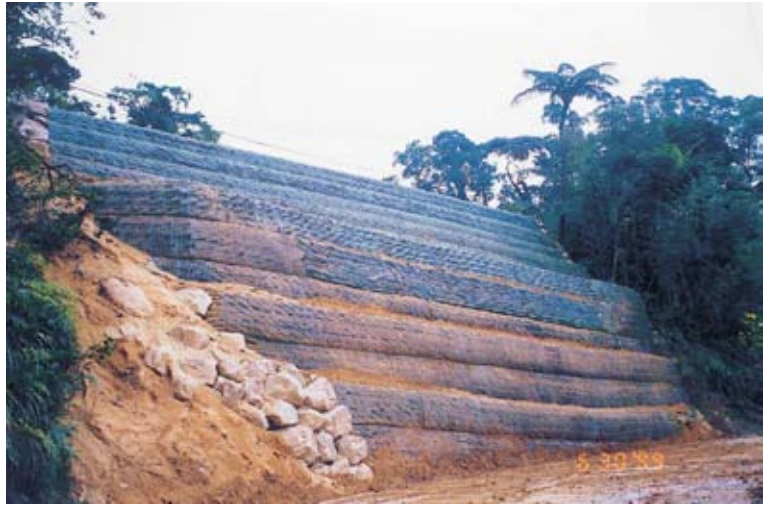
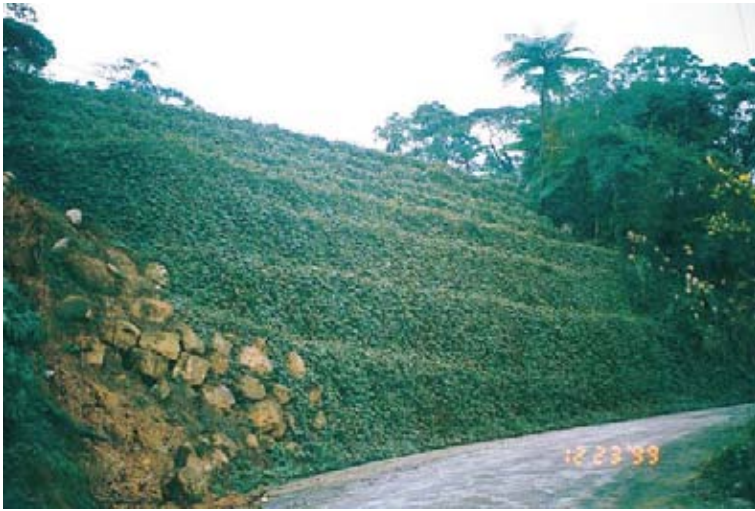
The introduction of ParaDrain™ to Taiwan has opened up the opportunity to carry out slope repairs for much longer periods during the year. This avoids delays in the work and thereby minimizes the time of disruption due to road closure. Such was the case at Wan Li where ParaDrain™ 100/15 was used to construct the 12metre slope as shown in the cross-section. ParaDrain™ allowed the rapid dissipation of pore water pressures during construction and ensured that the work could be completed in a very rapid 3 week period. After 6 months the vegetation on the slope had recovered thus ensuring a permanently stable structure into the future.
